Morphology and Sedimentology of Panther Creek, Montgomery County Preserve

Erik D. Scott, Ph.D. – E&P Geoscience, LLC

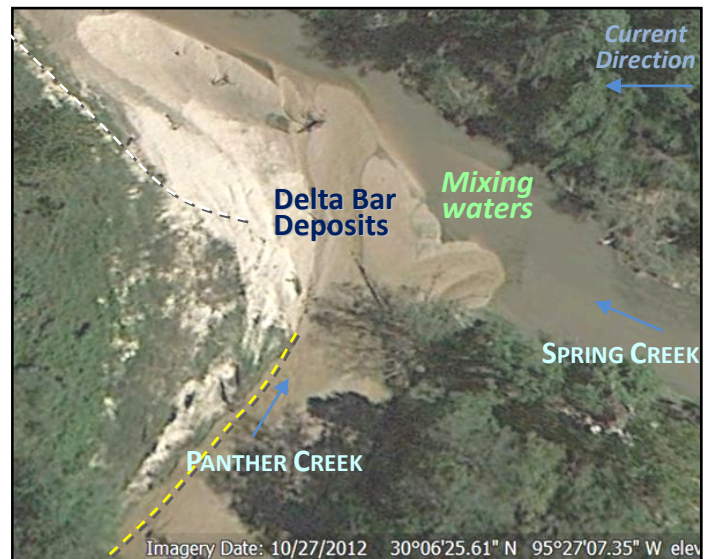
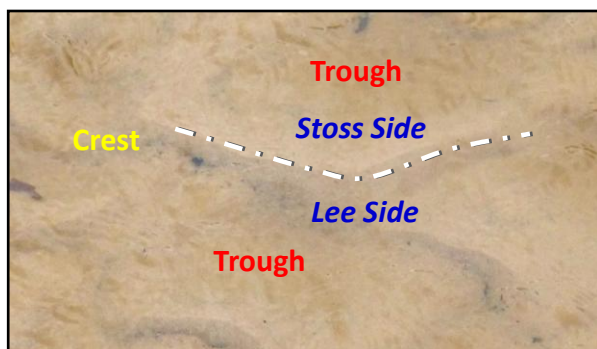
Stop 1 – Confluence of Panther Creek and Spring Creek

Here you can see the clearer, less sediment laden, lower density water from Panther Creek mixes with the muddier, more sediment laden, higher density water of Spring Creek and small swirling patterns (**eddies**) are formed on the surface of the water where these different density waters meet. As the smaller Panther Creek flows in the larger Spring Creek, a **delta bar** can typically be found as sediment in the faster flowing Panther Creek falls out of the water column when it encounters the slower moving waters of Spring Creek.

In the shallow portions of Panther Creek **ripples** are forming and migrating along the bottom of the creek. If you get in the creek and watch a single ripple for a minute or two, you can see sand grains bouncing along moving up the stoss (upcurrent) side of the ripple and then deposit on the lee (down current) side of the ripple. The whole ripple will move down the stream in this fashion.
